IMPORTANT SAFETY NOTICE

NHTSA CAMPAIGN NUMBER 07C006

Graco Children's Products Inc. ("Graco") has decided that certain ComfortSport™ Car Seats ("child restraint systems") fail to conform with Federal Motor Vehicle Safety Standard (FMVSS) No. 213, Child Restraint Systems. Our records indicate that you may own one of the affected child restraints.

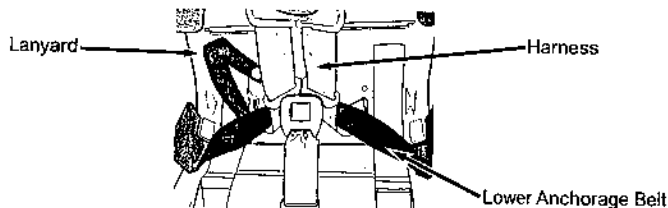
INCORRECT ROUTING FOR REAR-FACING MODE

On some of these child restraints, the Lower Anchorage belt was misrouted under the shoulder portion of the harness during assembly, instead of under the crotch belt/buckle section of the harness. If the child restraint is installed in the rear-facing mode and the Lower Anchorage belt is attached to the vehicle's LATCH anchor, the seat back angle of the child restraint can exceed 70 degrees in a frontal crash. This increased rotation may increase the risk of injury to the child.

Remove the seat pad and refer to the following pictures which show incorrectly routed and correctly routed Lower Anchorage belts. If your child restraint has an incorrectly routed Lower Anchorage belt (with the belt routed behind the shoulder portion of the harness), reroute the Lower Anchorage belt as described in Step 3. If the routing is already correct, reinstall the seat pad making sure you reattach using all the connections. Please refer to your ComfortSport Instruction Manual to reinstall your child restraint in your vehicle. If you do not have an Instruction Manual, go to www.gracobaby.com or call 1-800-345-4109.

Remove the Lower Anchorage belt from behind the harness straps and place it under the crotch strap portion of the harness as shown above, keeping the belt flat and tight against the child restraint so that it does not interfere with the harness system. The lanyard attaching the Lower Anchorage belt may be on either the right or left sides of the harness. Depending on which way your lanyard is mounted, assemble as shown above.
