US Route 20 (Lake Street) at J.F. Kennedy Drive Red Light Running (RLR) Statistical Analysis Report May 4, 2017

US Route 20 (Lake Street) at J.F. Kennedy Drive
Addison, Illinois

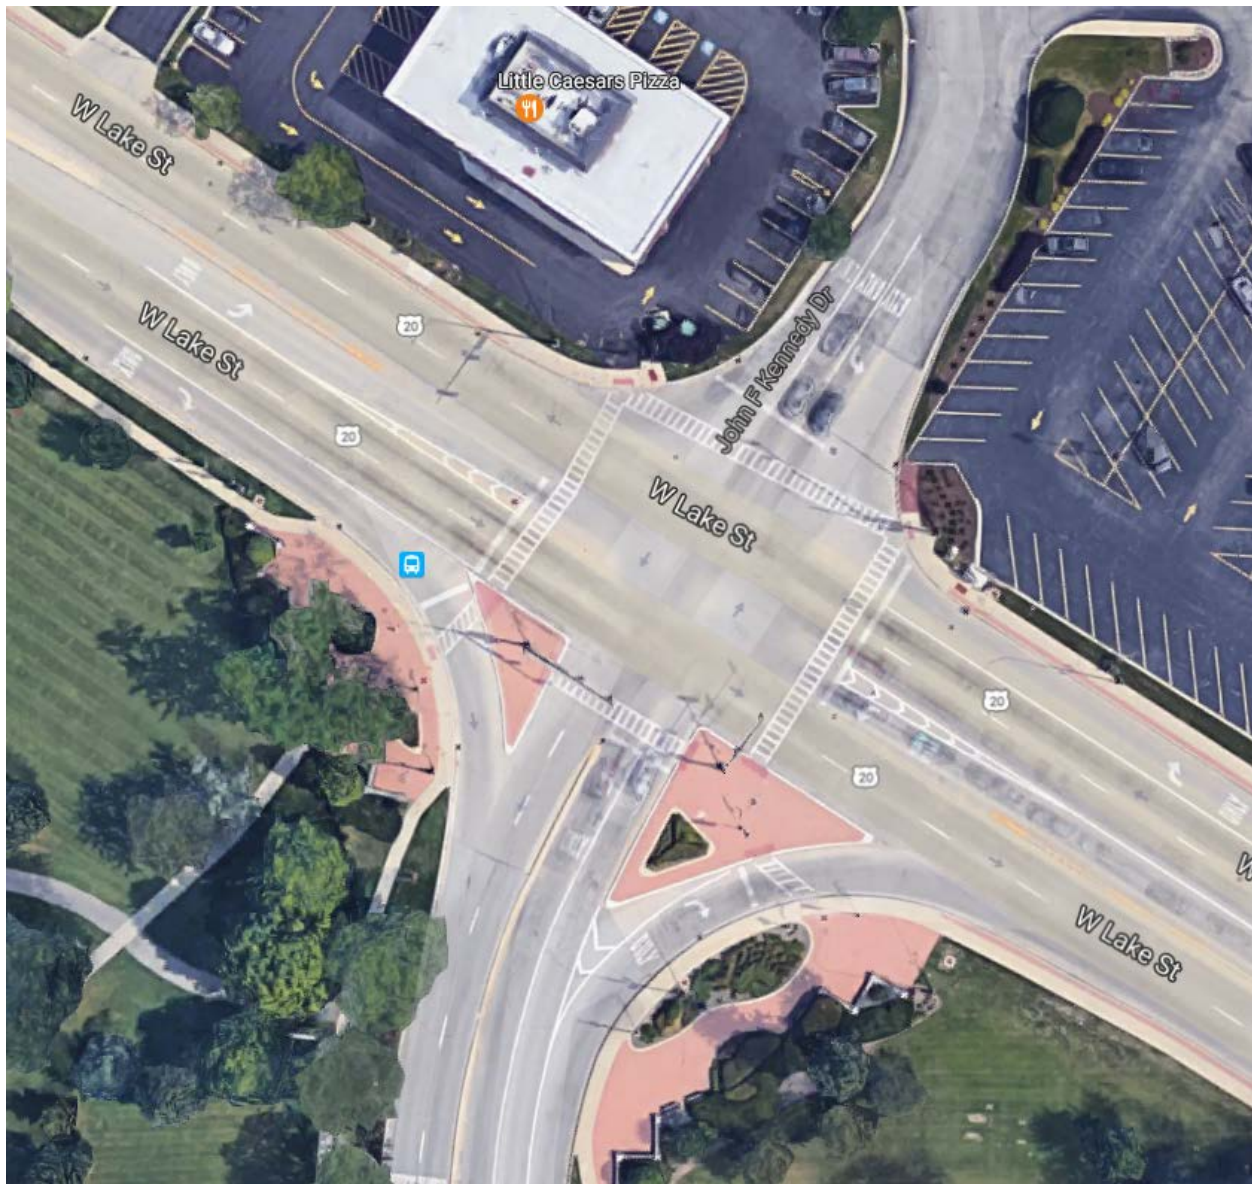
- RLR Photo Enforcement System monitors violations occurring on the northbound and eastbound approaches of the intersection.
- RLR Photo Enforcement System installed on November 20, 2012.

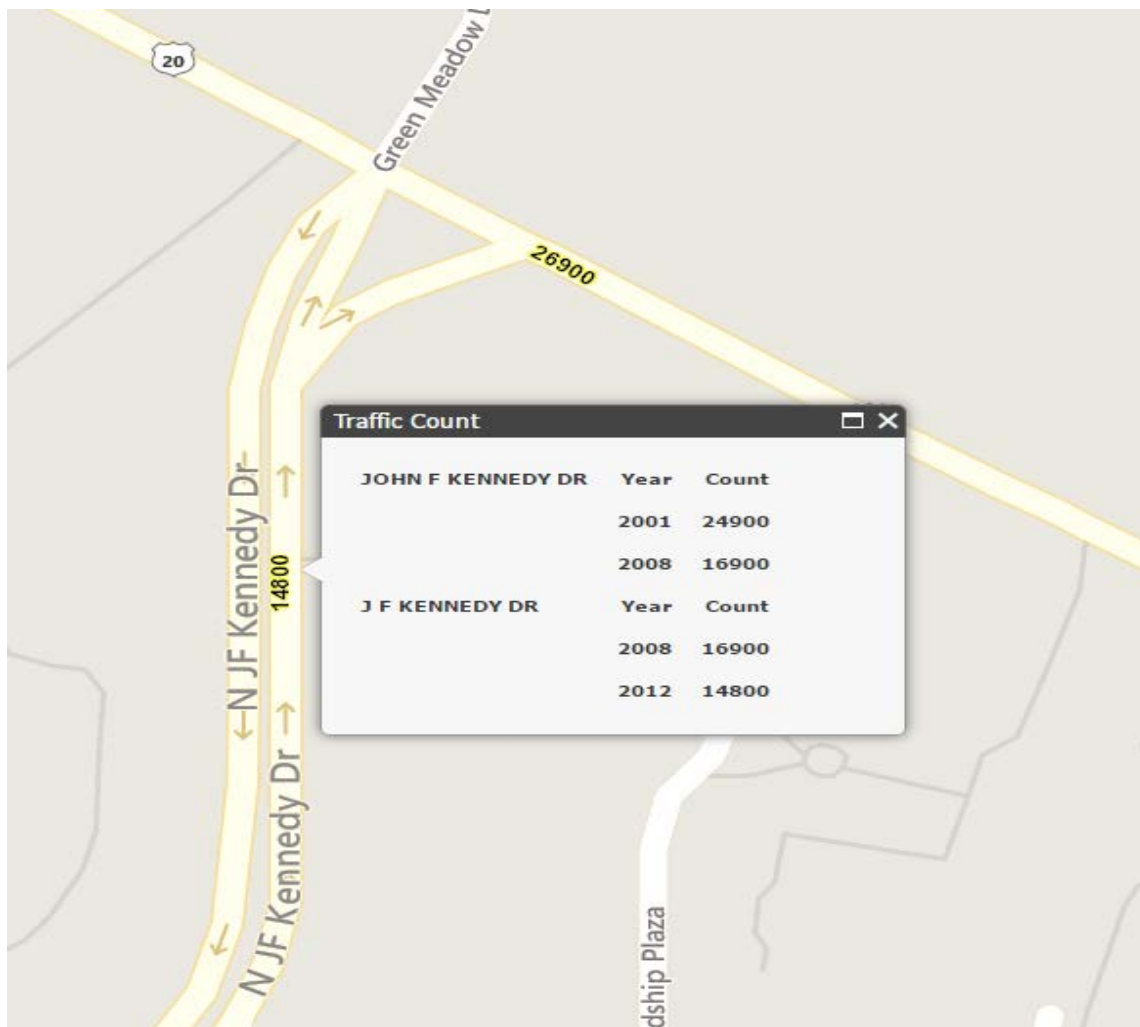
US Route 20 (Lake Street) at J.F. Kennedy Drive (Northbound)

- 24,900 (2001)
- 16,900 (2008)
- 14,800 (2012)

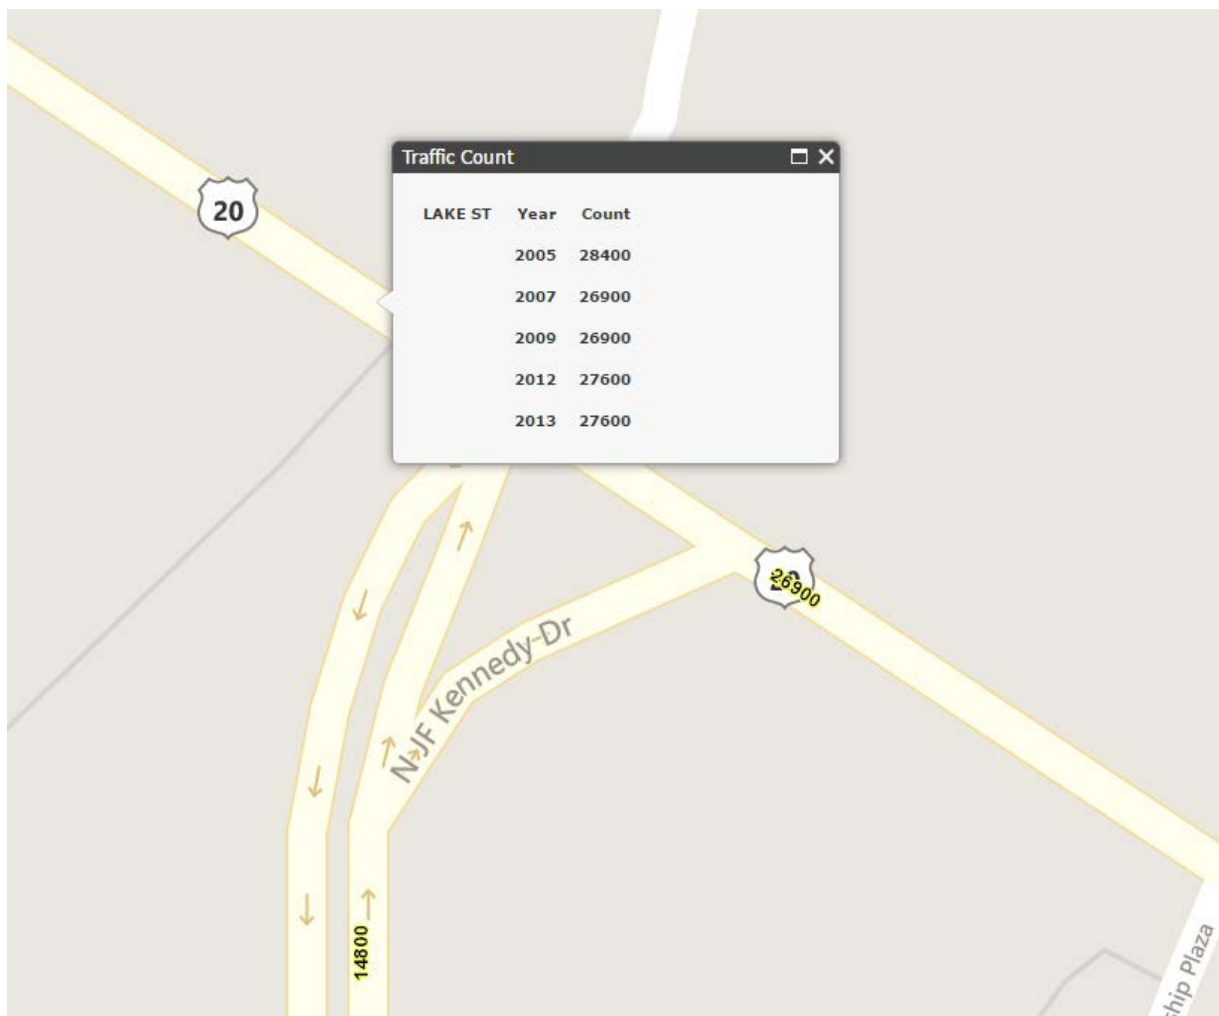
US Route 20 (Lake Street) at J.F. Kennedy Drive (Eastbound)

- 28,400 (2005)
- 26,900 (2007)
- 26,900 (2009)
- 27,600 (2012)
- 27,600 (2013)
